**PHYSICAL/CAPITAL NEEDS ASSESSMENT  
RESERVE ELEMENTS REVIEW**

**NEW COLUMBIA OWNERS ASSOCIATION**

4605 N TRENTON ST.  
PORTLAND, OR

OCTOBER 2017

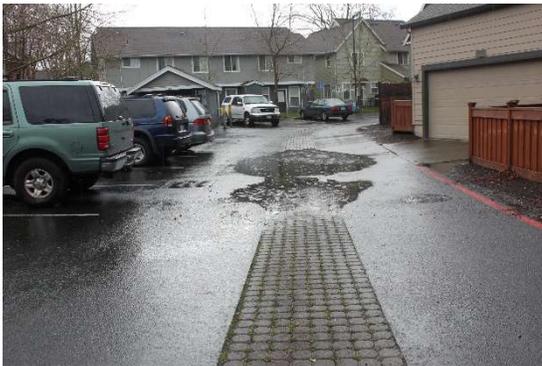
At the time of my inspections in 2016, there were multiple areas of the paver strip that had ponding of water, vegetation, and settled pavement of more than 1 inch. Based on my inspection in July 2017 these conditions do not appear to have changed. Although water ponding was not visible at the time as there had not been rain for some time, vegetation, and settled pavers were observed.

Water ponding on paver strip<sup>2016</sup>

It does not appear that the paver strips are functioning as well as was originally intended, with water ponding, settlement of pavers, vegetative growth between pavers, and an accumulation of silt evident.

At a minimum depressions should be repaired and broken pavers/cement replaced.

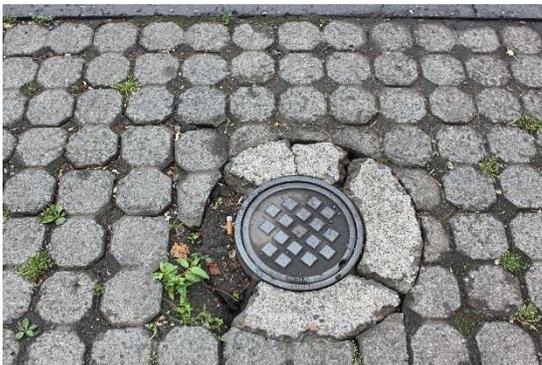
Vegetative growth/silt/fractured cement<sup>2016</sup>

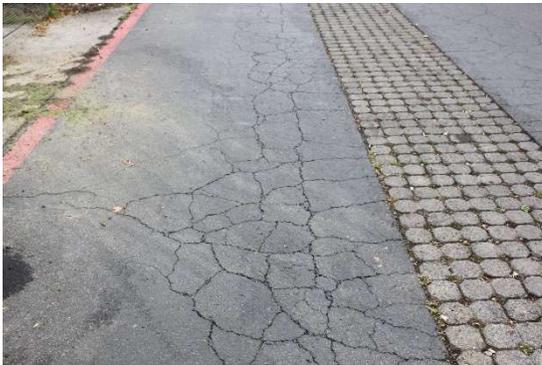
As stated above, there are areas that currently appear to be failing and will need to be repaired. Most of the 12 alleys with pervious paver strips have asphalt on either side of the pavers with alligating and cracks. There are alleys that are all asphalt that also have cracks and fractures that will need to be repaired. It was noted that large garbage trucks utilize these alleys to collect garbage. The weight of the trucks, particularly on the alleys with pervious paver strips, may be breaking down the asphalt at a quicker rate than anticipated.

Alligating of pavement in alley<sup>2016</sup>

The failure of the asphalt in the alleys with the pervious paver strips and soakage trenches should be reviewed by your contractor or engineer to determine how best to address this condition and to keep it from recurring. This can be done in conjunction with the drainage issues listed above under Storm Drain Pavers.

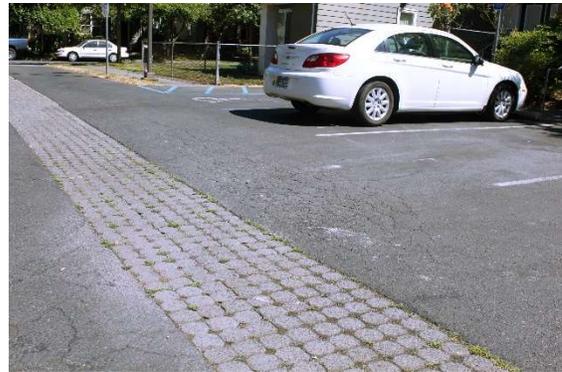
Alligating of pavement<sup>2017</sup>

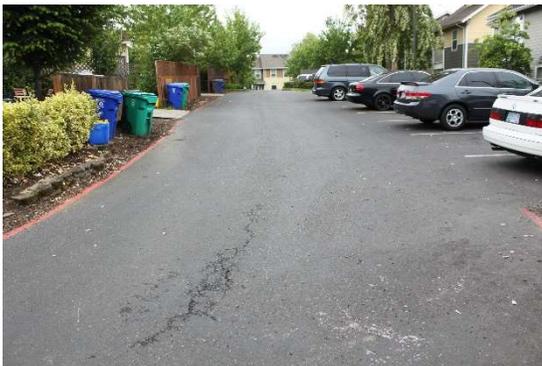
Fractures/cracks in pavement in alley<sup>2016</sup>

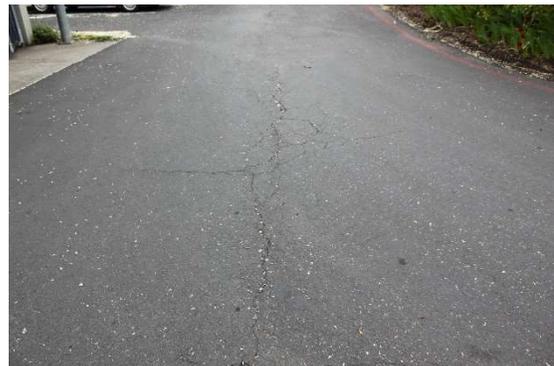
Fractures/cracks in alley<sup>2016</sup>

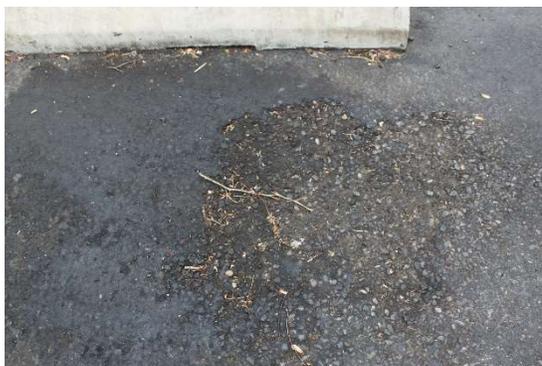
Oil stains: A few instances of oil stains were noted while inspecting the property. It appears that the oil stains are from automobiles parking at the property. It is important to keep oil from sitting on top of the asphalt as it tends to soften the surface. Recommend all areas with oil stains be cleaned regularly. Repairs should be made as necessary.

Oil stains/degradation of asphalt<sup>2016</sup>

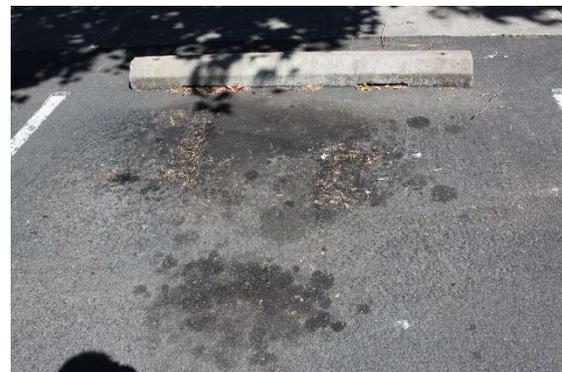
Oil stains on asphalt<sup>2017</sup>

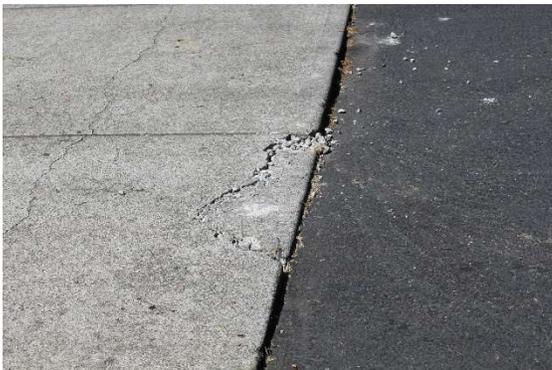
According to management, there is approximately 94,090 square feet of concrete pavement walks throughout the property that the Owners Association is responsible for maintaining. Currently, management has scheduled cleaning of the exposed surfaces to remove dirt and surface deposits every four years. Particularly slick surfaces may require more frequent cleaning to prevent a tripping or slip hazard. This can be done as needed on a small scale basis.

Fractured sidewalk/1½” change in grade at near 9668 N. Woolsey Avenue<sup>2017</sup>

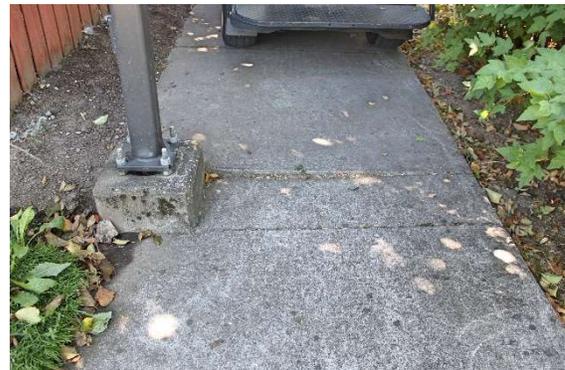
Uneven sidewalk between buildings on N. Woolsey by lamp W401<sup>2017</sup>

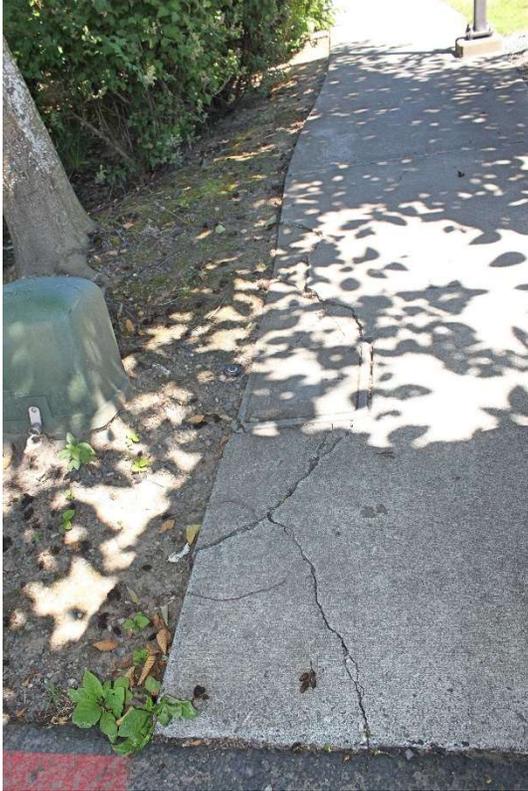
Fractured sidewalk<sup>2017</sup>

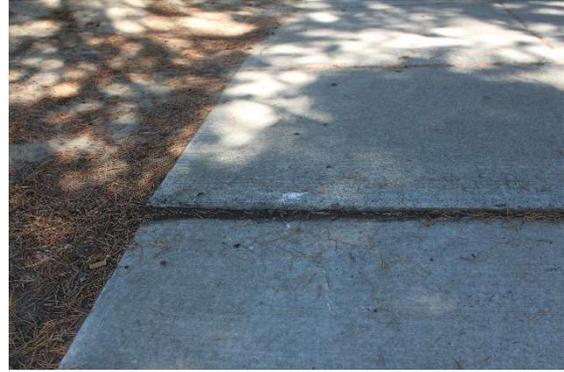
Uneven sidewalk<sup>2017</sup>

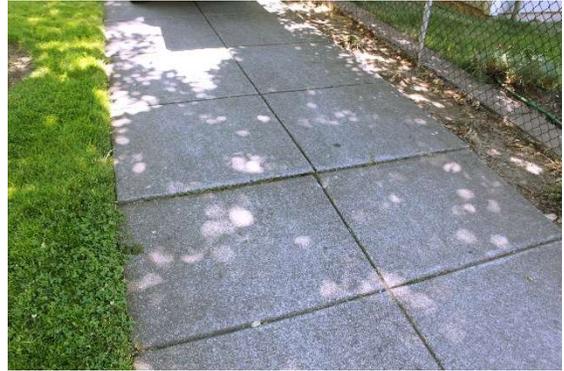
Uneven sidewalk<sup>2017</sup>

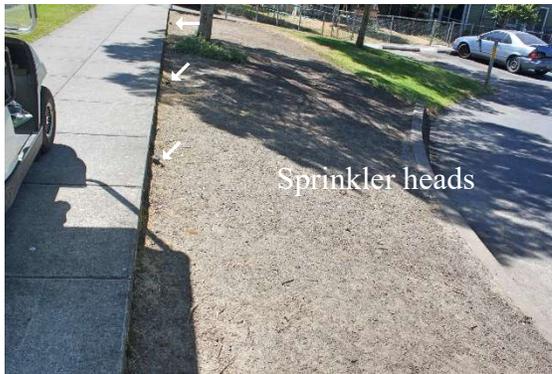
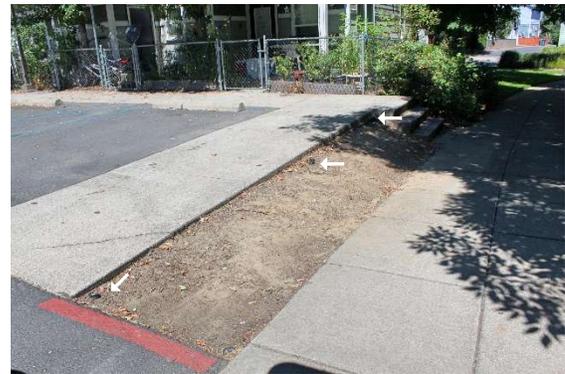
There were also areas in which plant material has died leaving bare dirt subject to erosion, which negatively impacts the stormwater system, in addition to being unsightly.

Examples of bare ground subject to erosion<sup>2017</sup>

All sprinkler heads should be adjusted or replaced to spray away from foundations and buildings. Steps should be taken to stabilize the soil in these areas to minimize/prevent erosion. Suggestions from the Civil/Soils Engineer should be obtained at the same time they are looking at drainage. Certain plants will help stabilize the soils as will retaining walls. This was discussed in the respective partnership reports completed in 2016.

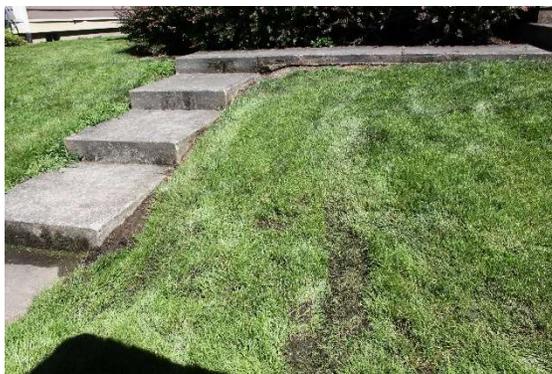
The system had been operating for several months at the time of my inspection. Several conditions suggest watering system settings should be checked and adjusted to provide adequate water without overwatering and reduce any erosion around sloped areas and steps. This should be done at least annually.

Evidence of overwatering<sup>2017</sup>

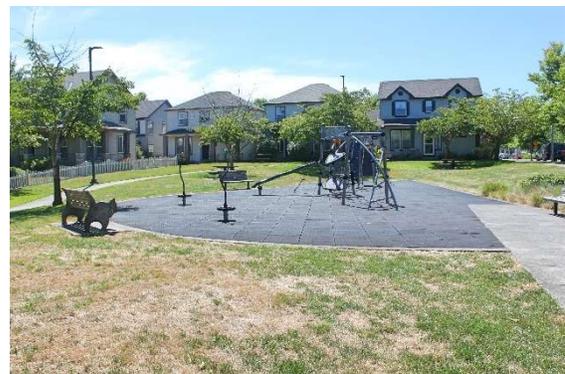
Evidence of inadequate irrigation<sup>2017</sup>

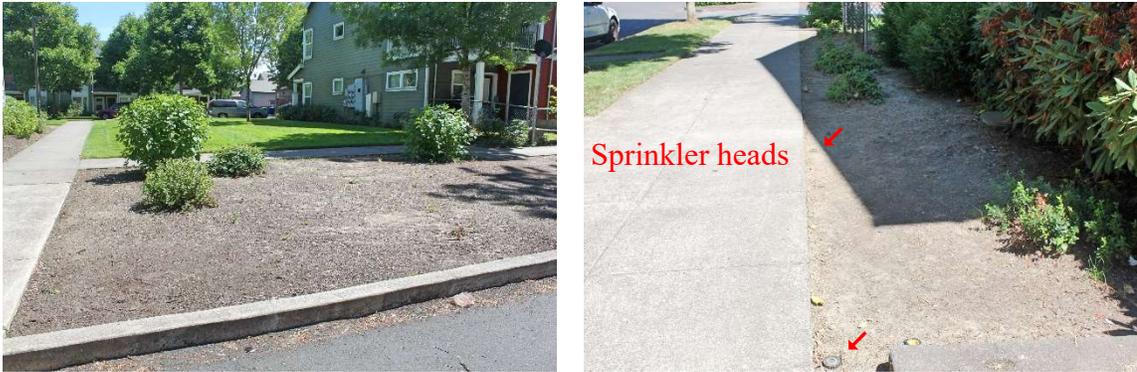
There are also several areas in which sprinklers are located where plants have subsequently died leaving bare ground. Plants should be replaced to minimize erosion and stabilize the ground. If the plants are not going to be replaced in the near future, it is suggested that the sprinkler heads be capped until the plant material can be replaced.

Examples of beds with missing plant material<sup>2017</sup>

- For the purpose of this report, anticipate installing plant material in the areas in which original plants died or are diseased in year 2. Management should plan for ongoing replacement of dead/diseased plant material. New plants should be selected based on sun exposure and soil type to give them the best chance to thrive. Estimate \$5,550 annually based on information from ValleyScapes.

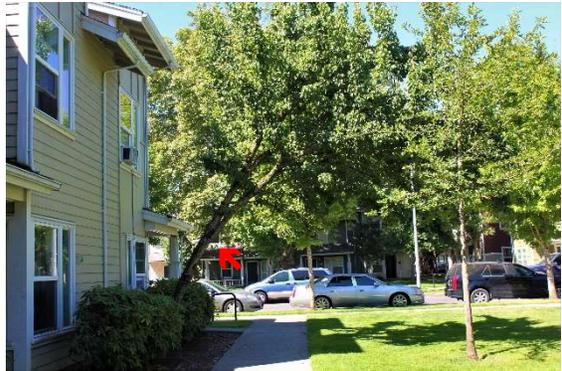
Example of leaning tree 9130 N Woolsey<sup>2017</sup>

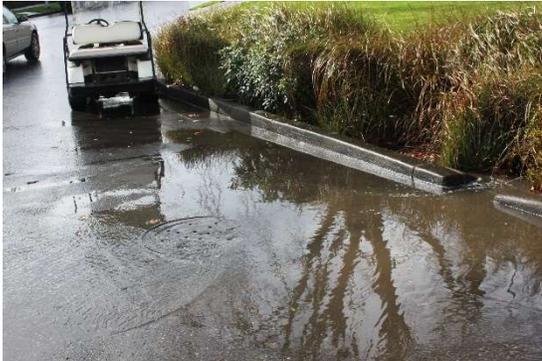
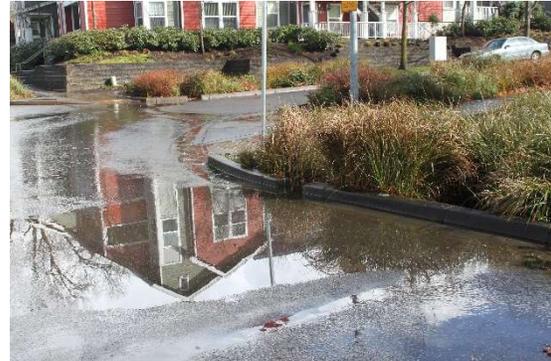
In addition to the above, there are bio-swales located on streets throughout the property that are part of the stormwater system. My understanding from management is that these areas are to be maintained by the City of Portland. It was noted during my inspections that several of the bio-swales are overgrown with a couple that appear to have had plant material that died off leaving bare ground. Additionally, on one occasion in 2016 the swales at the north end of the property were flooding after a rain storm. This area should be monitored for further flooding. City officials should be notified regarding the condition of the swales and the flooding issue at the north end of the property.

Overflowing bio-swale and standing water at N Fiske Ave. and N Cecelia St. <sup>2016</sup>

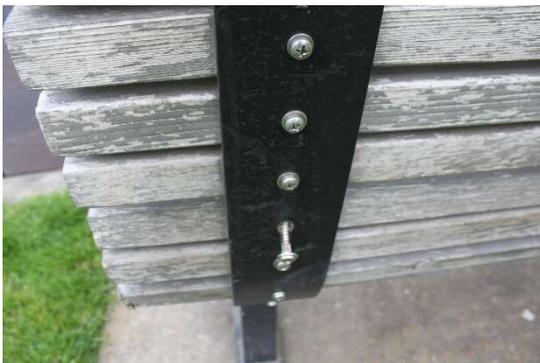
At the time of my inspections some wood slats were missing and a few bolts were loose. These should be repaired/replaced.

Loose bolt<sup>2016</sup>

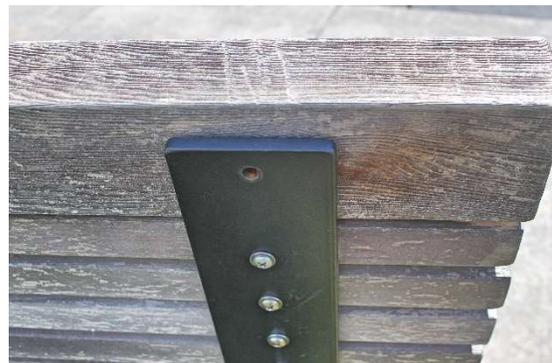
Missing bolt<sup>2016</sup>

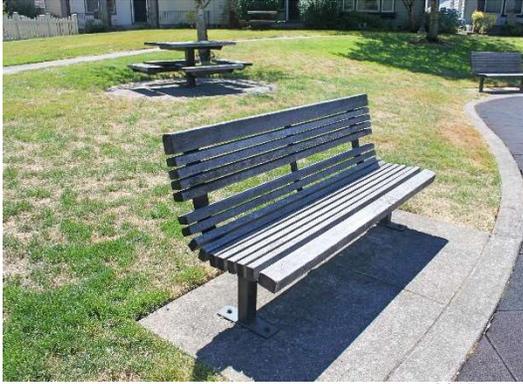
Example of missing slat on bench<sup>2017</sup>

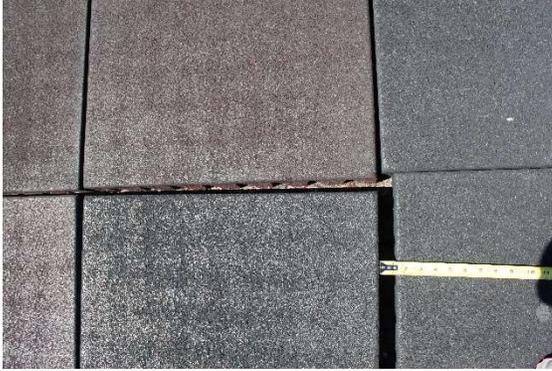
1" Gap in rubber tiles<sup>2017</sup>

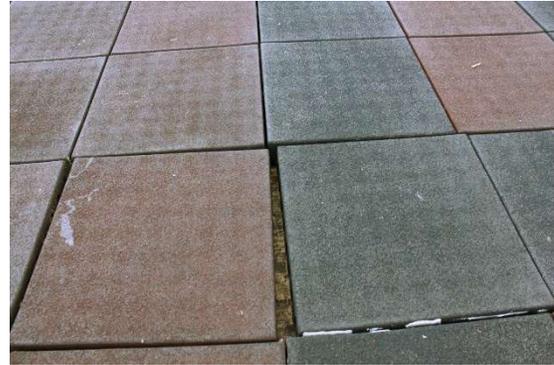
Example of shifted tiles<sup>2016</sup>

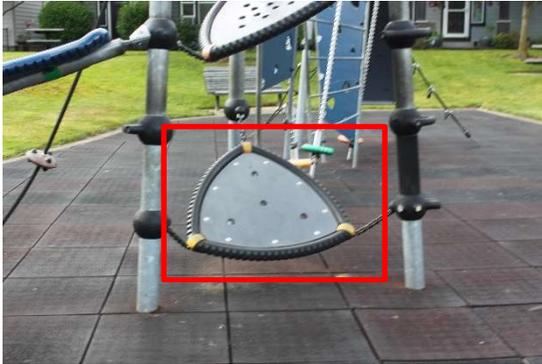
The Bellatrix play structure was made by KOMPAN. Mr. Wride inspected the Bellatrix structure and indicated that there are some missing pieces, specifically a triangular deck and a bivvy seat. There are also a few bolts that have rusted and need to be replaced.

Example of missing piece<sup>2016</sup>

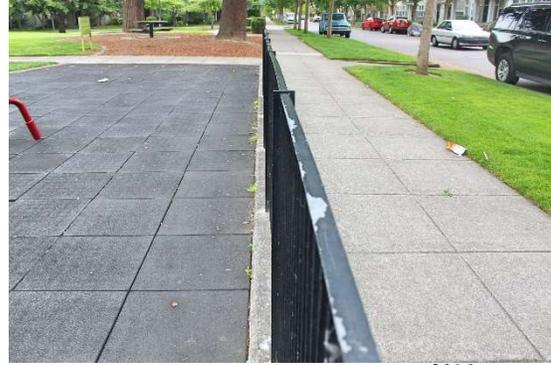
Example of paint chipping<sup>2016</sup>

Metal rails/parts should be cleaned and painted with a product appropriate for the surface being painted. It is important that the metal surfaces be prepped well to remove all rust, prime any bare surfaces, and scuff-sand the surface to ensure good adhesion.

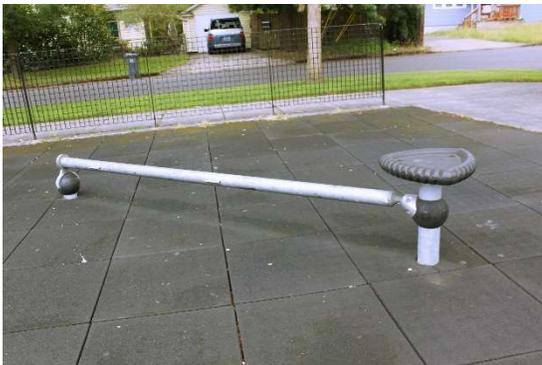
The Argo is made by KOMPAN. It is missing a large blue piece that moves. According to management, they removed this piece and are storing it. Mr. Wride indicated that this piece can be reinstalled. Estimated cost for reinstallation was not available at the time this report was completed.

Argo in Pocket Park 2<sup>2016</sup>

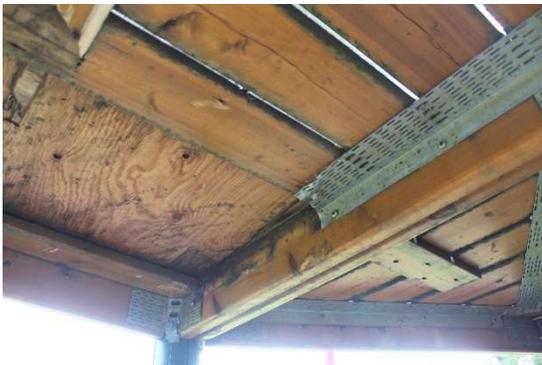
The paint and finish on numerous areas of the structure has worn off and a platform on the structure broke but appeared to have been temporarily repaired. In talking with professionals, estimated useful life for this type of structure is 15 years.

Damage to platform<sup>2016</sup>

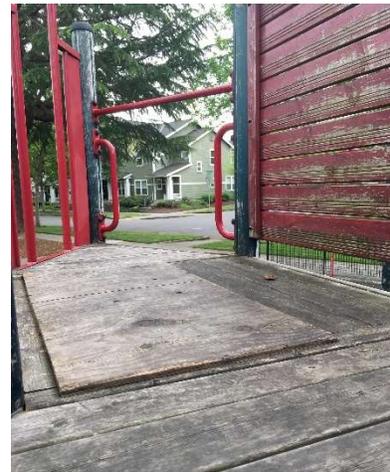
Temporary fix to platform<sup>2016</sup>

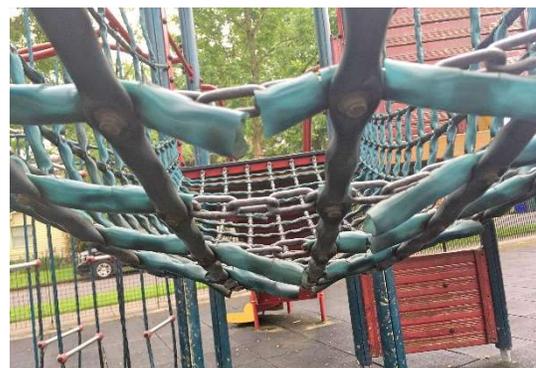
Plastic sleeves tearing away from chains<sup>2016</sup>

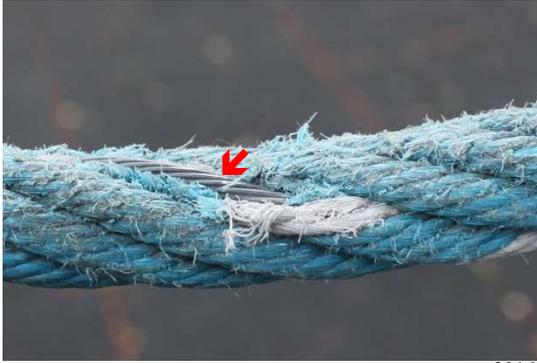
The Homestead play structure was manufactured by KOMPAN. According to Mr. Wride, this equipment may have a useful life of more than 20 years. Mr. Wride inspected the Homestead structure and indicated that it appears to be in good shape but could be cleaned to remove dirt and debris. However, he did point out that the ropes should be monitored and if more metal becomes visible through the fibers the ropes may need to be replaced (see picture below).

Rope fibers wearing exposing metal cable<sup>2016</sup>

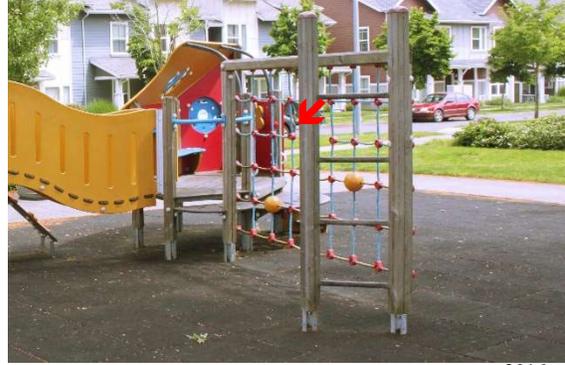
Location of ropes with exposed metal<sup>2016</sup>

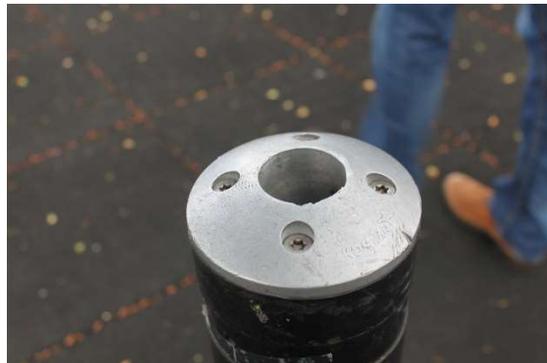
Play Equipment – Pocket Park 3 – Satellite Binoculars/Megaphones: *Priority A & C*  
 The Satellite Binoculars/Megaphones are made by KOMPAN. This equipment has a useful life of approximately 20 years. Either a binocular or megaphone is missing from one of the stands.

Post missing top element<sup>2016</sup>

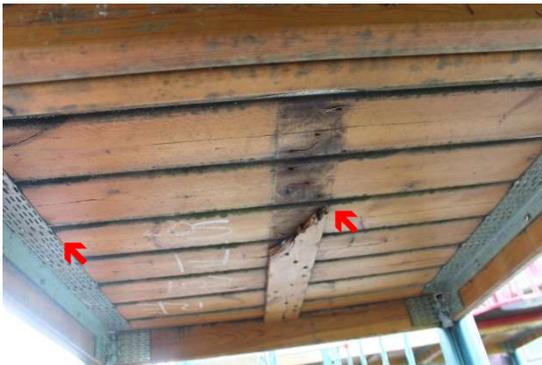
The paint and finish on numerous areas of the structure has worn off, a platform on the structure broke but appeared to have been temporarily repaired, and two of the roof structures are swollen and chipped along the edge, in addition to other elements that are worn out. In talking with professionals, estimated useful life for this type of structure is 15 years.

Damage to platform<sup>2016</sup>

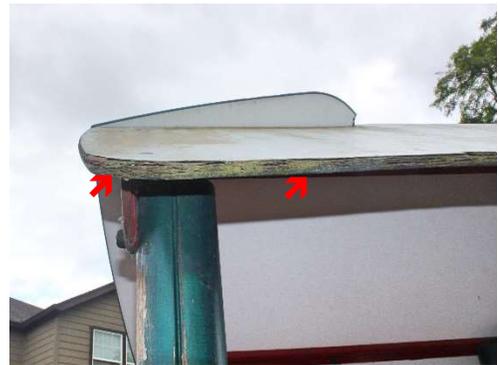
Roof underlayment swelling<sup>2016</sup>

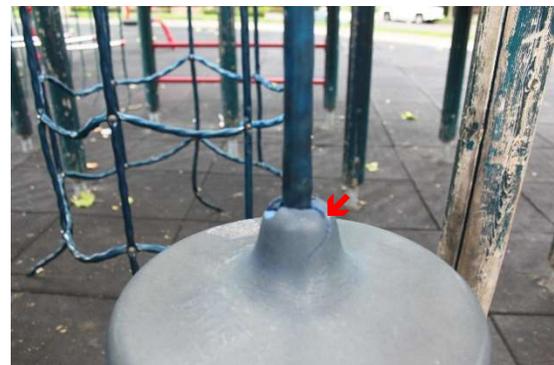
Fractured play element<sup>2016</sup>
