**PHYSICAL/CAPITAL NEEDS ASSESSMENT  
RESERVE ELEMENTS REVIEW**

**NEW COLUMBIA OWNERS ASSOCIATION**

4605 N TRENTON ST.  
PORTLAND, OR

OCTOBER 2017

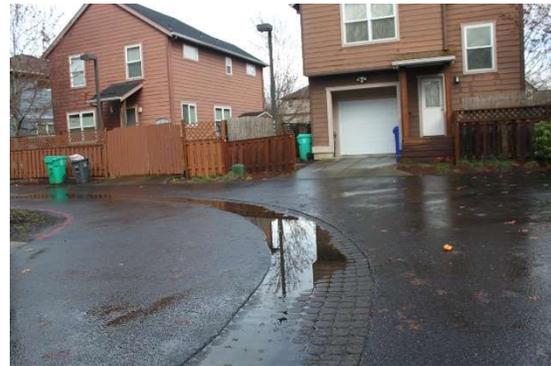
Water ponding<sup>2016</sup>

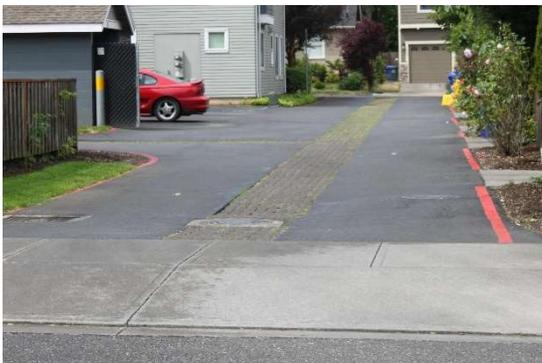
Vegetative growth/settlement<sup>2016</sup>

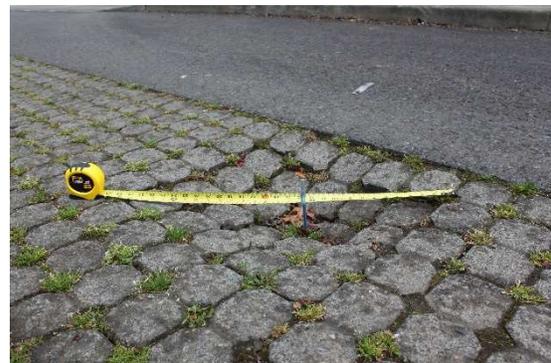
Vegetative growth/settlement<sup>2016</sup>

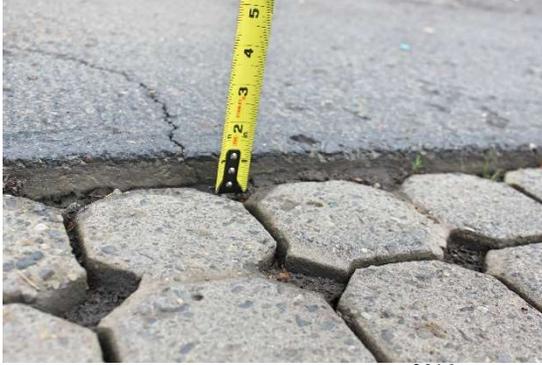
Settlement of paver strip<sup>2016</sup>

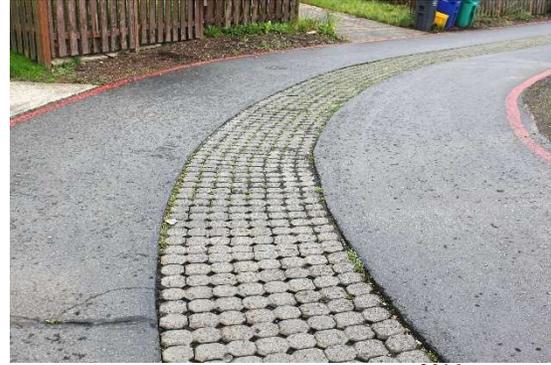
Settlement of paver strip<sup>2016</sup>

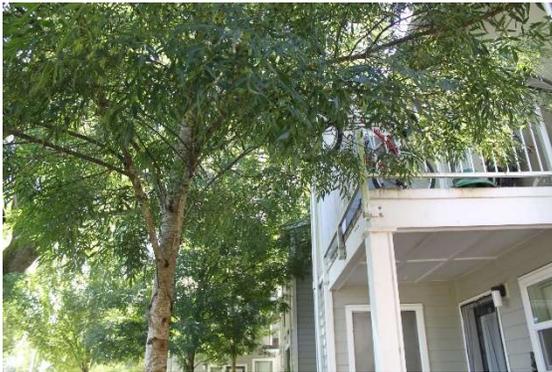
Example of trees hanging over/on building<sup>2017</sup>

It is recommended that all trees be evaluated by a qualified arborist to determine the health of the trees and identify those that should be pruned and/or removed to keep the trees healthy and the property safe from trees that are diseased and prone to falling.

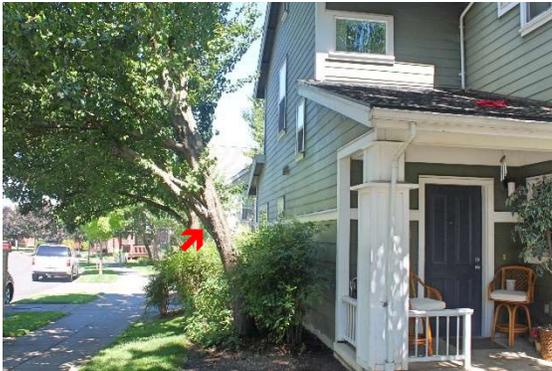
Example of leaning tree<sup>2017</sup>

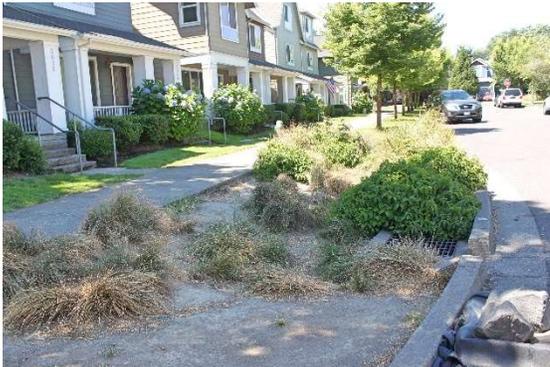
↑2017

Sparse vegetation in bio-swale on N Esperanza St.

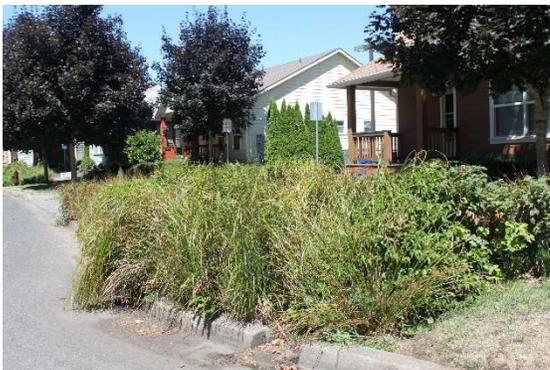
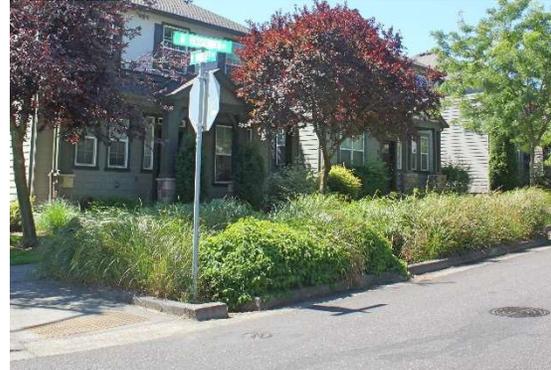
Bio-swales with overgrown vegetation - 2017

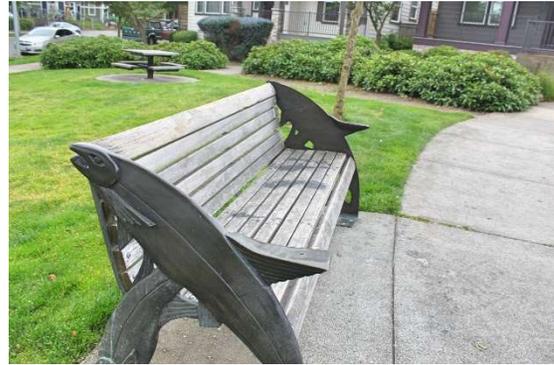
Example of custom bench<sup>2016</sup>

Due to how these benches are attached to the base it would cost the same or less than \$1,000 to replace the bench with a new bench that may include a warranty. With the exception of the custom bench frames, the cost of a new 5-foot, fir bench from the same manufacturer is \$805 excluding shipping.

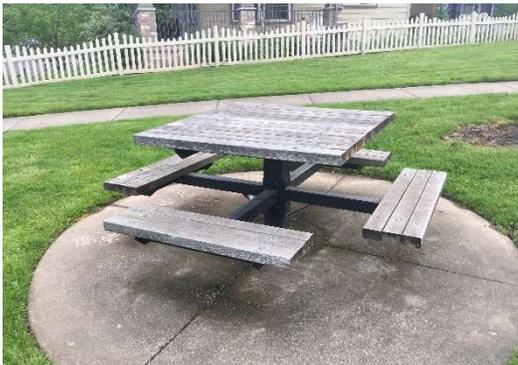
Example of picnic table<sup>2016</sup>

There are approximately 10 picnic tables located in the four pocket parks. The tables are from FairWeather and are Model F-4, 48 inches. The wood slats on all tables were replaced in 2012 for approximately \$10,000. The wood is unfinished pine. The cost to replace a table with one from the same manufacturer is \$2,000 excluding shipping and installation.

- For the purpose of this report, anticipate replacing the wood slats in years 2, 9, 16, 23 and 30. Estimate \$1,000 per table.

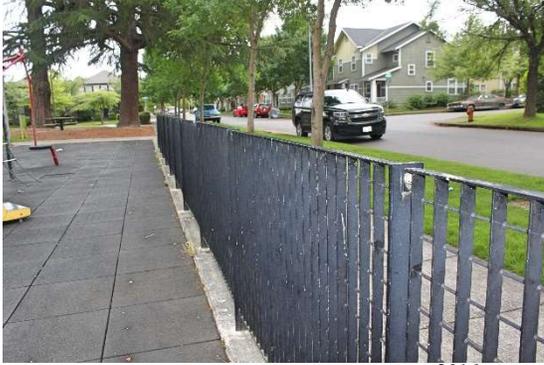
Metal fencing Pocket Park 2<sup>2016</sup>

The decorative metal fence along the south side of Pocket Park 2 is approximately 60 feet long and appears to be in good condition with the exception of the paint. Some peeling was noted on the surface of the metal. The fence is secure and not loose. Although it was listed as having a useful life of 15 years, I expect that it will last at least 20 if not 25 years. I recommend that it be repainted to extend its useful life and minimize any rusting that might occur.

Metal rails/parts should be cleaned and painted with a product appropriate for the surface being painted. It is important that the metal surfaces be prepped well to remove all rust, prime any bare surfaces, and scuff-sand the surface to ensure good adhesion.

- For the purpose of this report anticipate repainting the fence in year 2. Estimate \$25 per linear foot or \$1,500 to prep and repaint the fence.
- For the purpose of this report, anticipate an estimated useful life of 20 years (this should be reviewed annually and adjusted depending on condition). Anticipate replacement in year 9. Estimated cost of \$70 per linear foot including demolition of the old fence. Total cost \$4,200.

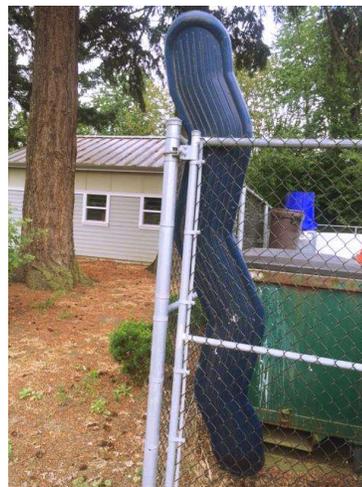
Argo component<sup>2016</sup>

The Argo is made by KOMPAN. It is missing a large blue piece that moves. According to management, they removed this piece and are storing it. Mr. Wride indicated that this piece can be reinstalled. Estimated cost for reinstallation was not available at the time this report was completed.

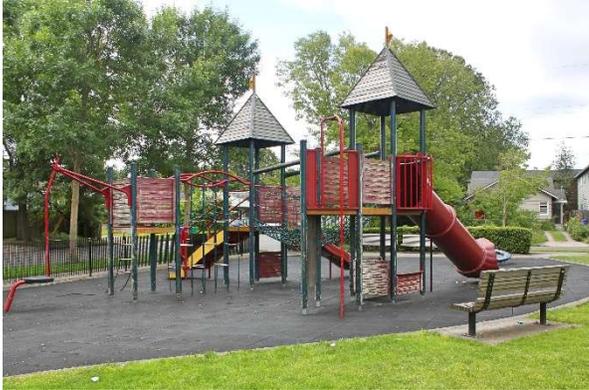
Play Structure II<sup>2016</sup>

The Play Structure II shown below was manufactured by HAGS. The structure is made with more wood and has not held up well to the elements and use.

The paint and finish on numerous areas of the structure has worn off and a platform on the structure broke but appeared to have been temporarily repaired. In talking with professionals, estimated useful life for this type of structure is 15 years.

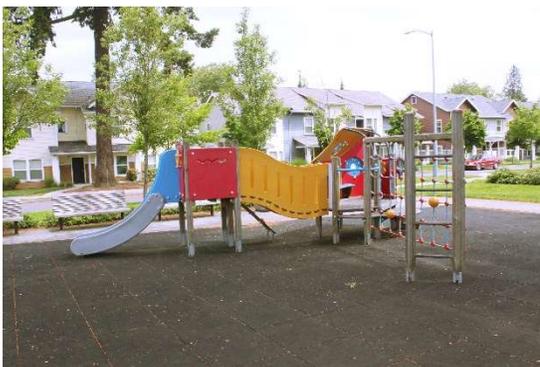
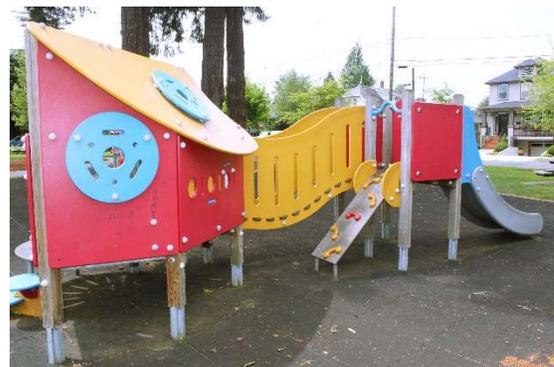
The Homestead play structure was manufactured by KOMPAN. According to Mr. Wride, this equipment may have a useful life of more than 20 years. Mr. Wride inspected the Homestead structure and indicated that it appears to be in good shape but could be cleaned to remove dirt and debris. However, he did point out that the ropes should be monitored and if more metal becomes visible through the fibers the ropes may need to be replaced (see picture below).

- For the purpose of this report, anticipate replacement in year 9. Current cost of this structure is approximately \$35,000 plus an installation fee of approximately \$9,800. Demolition of the existing equipment is estimated to cost \$7,000. Total cost \$51,800.

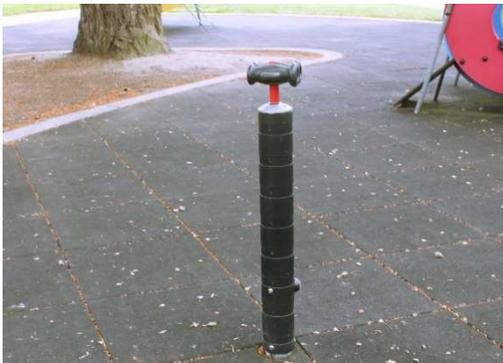
Binocular<sup>2016</sup>

Play Equipment – Pocket Park 3 – Satellite Binoculars/Megaphones: *Priority A & C*  
 The Satellite Binoculars/Megaphones are made by KOMPAN. This equipment has a useful life of approximately 20 years. Either a binocular or megaphone is missing from one of the stands.

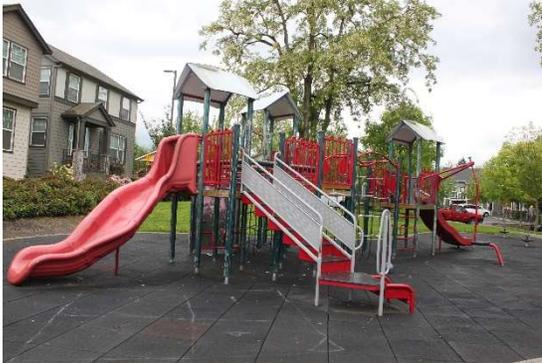
Play Structure I<sup>2016</sup>

The Play Structure I shown below was manufactured by HAGS. The structure is made with wood and some plastic. It has not held up well to the elements and use.

The paint and finish on numerous areas of the structure has worn off, a platform on the structure broke but appeared to have been temporarily repaired, and two of the roof structures are swollen and chipped along the edge, in addition to other elements that are worn out. In talking with professionals, estimated useful life for this type of structure is 15 years.
